January 8, 2018

Re: Gym Parapet Wall Collapse
Linderman School
Polson, MT.

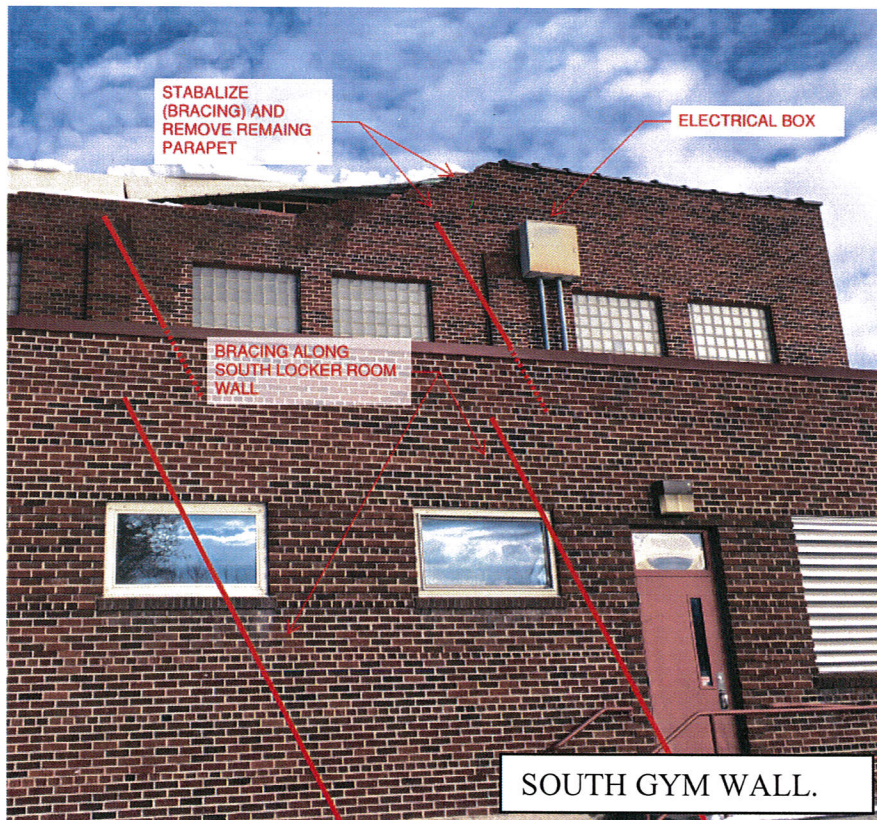
At your request, we have conducted a follow-up investigation for the collapse of the south parapet gym wall and locker room roof that occurred since our previous site visit on Tuesday, January 2nd. Chris Schlegel (PE) and Mark Bradford (PE) met on-site with the Superintendent (Rex Weltz), the Maintenance Director (Dan Giles), and Paul Bishop (Paradigm Architects) to inspect the damage and determine steps required to stabilize the structure. The majority of the south gym parapet (~3'-0" tall) had peeled off of the gym wall and landed on the south locker room lower roof below causing the lower roof to collapse (in conjunction with additional sliding snow). A section of parapet is still remaining along the east and west end bays for the gym. The locker room roof framing consists of wood trusses at 16" o/c with 2x6 top chords, 2x diagonal members, and 2x10 bottom chords. The framing spans N/S and is supported by the interior gym brick wall and exterior locker room brick wall.

The gym roof consists of 2x12 rafters at 16" o/c spanning east/west and supported atop timber trusses approximately 21'-7" (6 bays). The trusses are supported on concrete columns which are partially inset into the brick walls on the north and side of the gym walls. A 6'-0" level was placed (along top section of column) on each of the concrete columns located on the south side of the gym. These columns were consistently +/- ½" out of plumb (outward, south). A 4'-0" level was placed at the top of the south gym wall between the columns which indicated the brick wall was out of plumb +/- ½" along the 2 middle bays only. The columns and wall on the north side were all plumb when measured at the same upper location. The exterior brick wall on the southside of the locker room was +/-1" out-of-plumb (outward, south) along the entire wall based on a 4'-0" level measured approximately 2/3 up the wall.

1. Isolate gym parking lot on all exposed sides with chain link fence to keep pedestrians safely away from the building. The gym was currently taped off along the parking lot and the fence was being delivered while we were on-site.
2. Hand remove snow on north parapet.
3. Install diagonal braces along the south locker room brick wall for stabilization.
4. Brace/stabilize the east parapet above the electrical box (currently peeling off) so that the parapet may be safely removed and the electrical box preserved from potential damage.
5. Install diagonal braces along the gym wall to the south locker room wall to stabilize the south gym wall.
6. Demo locker room roof and determine extent of damage on south gym and locker room walls once debris is removed.
