Tier 1 Assessment  
Linderman Gymnasium  
Polson, MT

**AEGIS**  
ENGINEERING  
INCORPORATED

RE: Linderman Gymnasium Polson, Montana

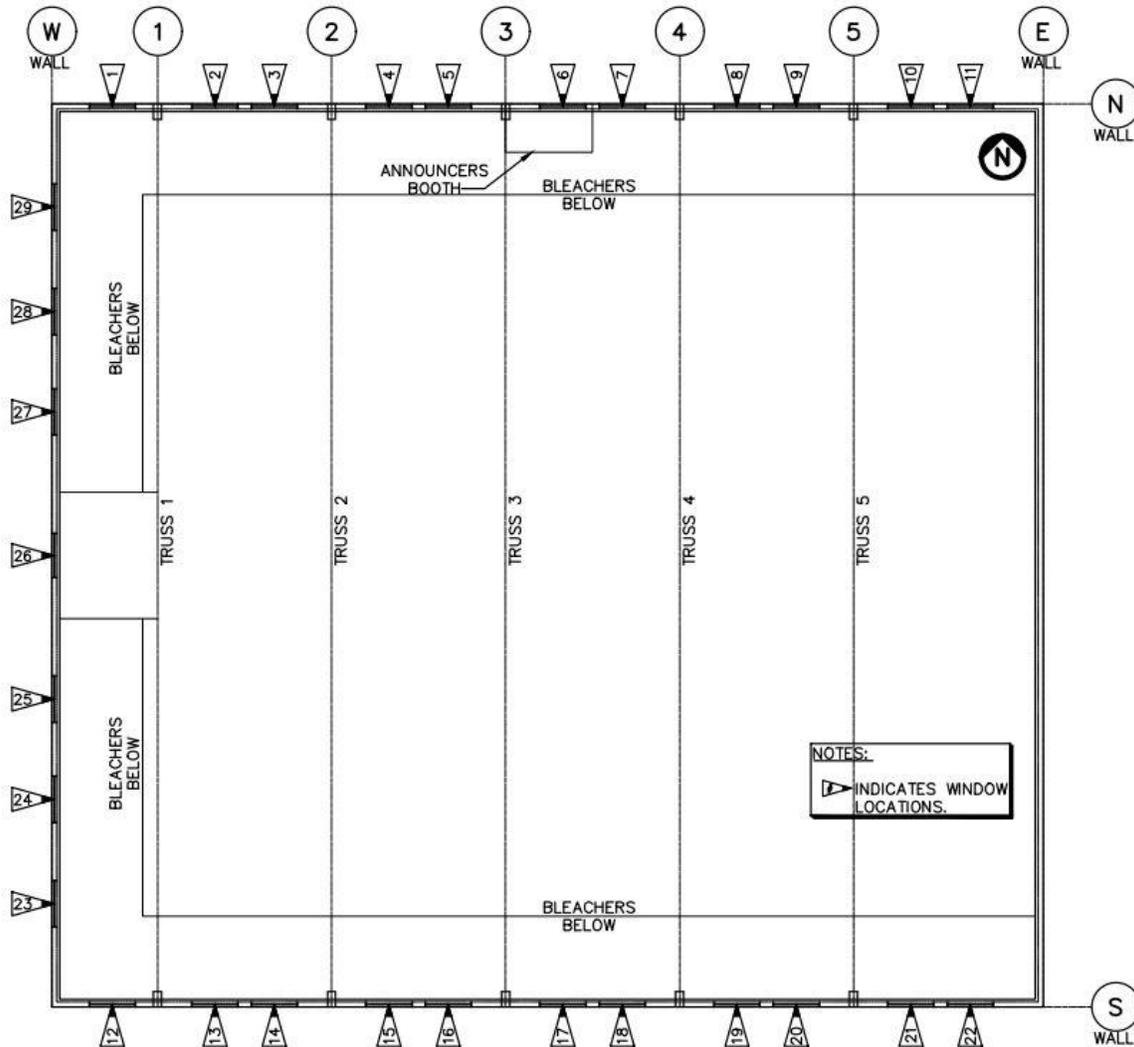
Figure 1 Gym plan view indicating column lines, truss numbers, and window locations.

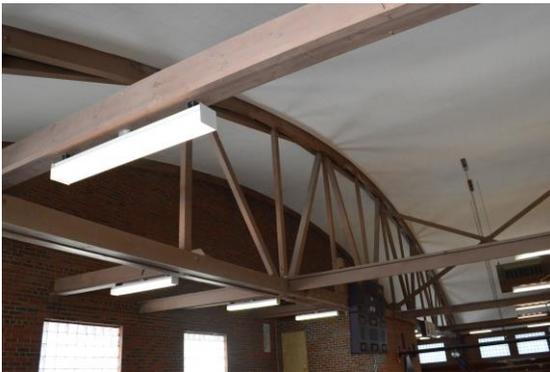
It was observed that the truss members showed signs of aging and checking through many of the truss top chord, bottom chord, web members, and wood splice members. At truss lines 3 and 4 the bottom chord of the truss has 7/16” steel plates added to the bottom and sides. At the bottom chord splice points the bolts washers were welded to the steel plates to reinforce the bottom chord member of the trusses and aid in supporting the roof top mechanical unit that was added during the remodel.

**Figure 2 Bowstring roof truss number 1**

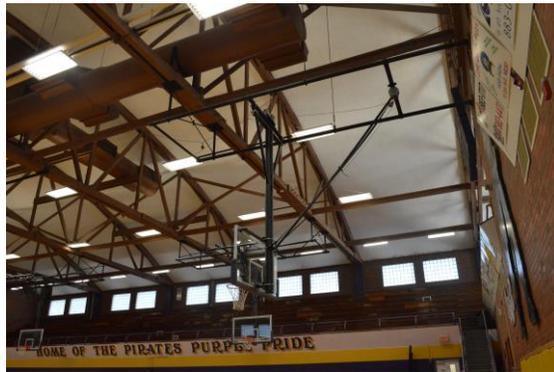
**Figure 3 Bowstring truss South end.**

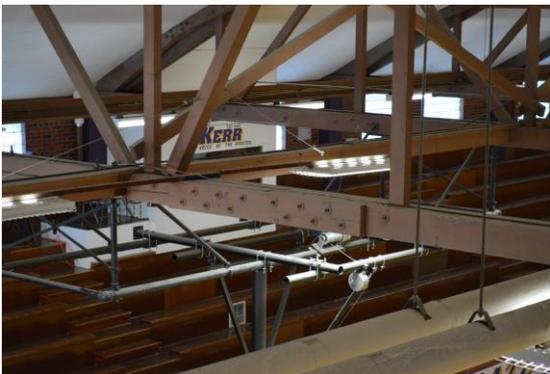
**Figure 4 Bowstring bottom chord splice**

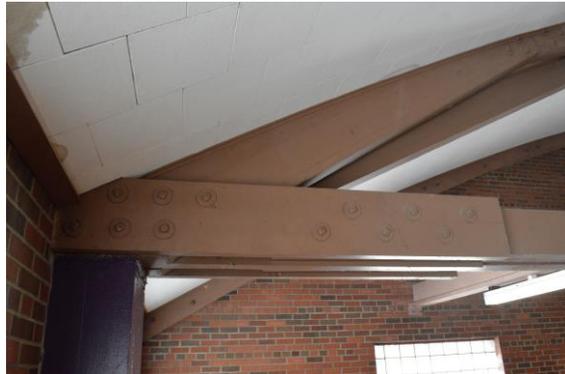
**Figure 5 Bowstring truss bearing end splice.**

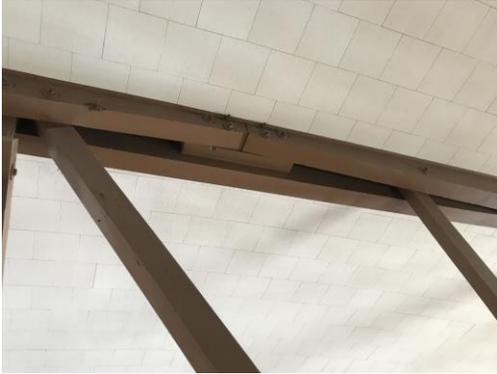
**Figure 6 Bowstring top chord splice.**

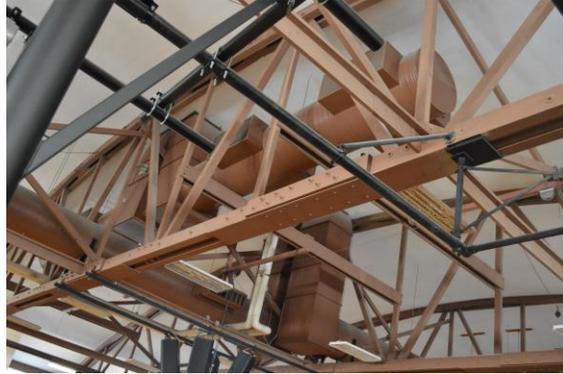
**Figure 7 Duct work and bottom chord reinforcing.**

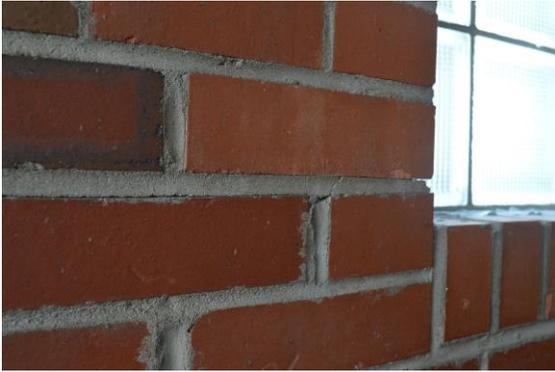
Cracking was found during the onsite observation. At the West wall in the South West corner cracking along mortar joints and through brick units was found propagating from the upper portion of the corner and traveling diagonally down and to the North. At the base of window 23 the separation was found to be large enough that the mortar had separated from the brick above and below and could freely move in the joint. Also found was at the location where the cracking extended to below the bleachers level the varnish was cracked and separating indicating the cracking was recent. Similar cracking was found along the South wall propagating up at a diagonal from below the bleachers to the West most window through the varnish layer. This cracking continued along the wall at the base of the window elevation and up at the columns along the mortar joint tot the East wall. At the South East corner wall cracking was found to propagate from the upper corner diagonally down and to the North along grout lines and through brick units to below the stairs. At the North West corner of the building diagonal cracking was found on the West wall around the openings and down to below the bleachers, this crack also travels through the varnish and appears to be recent. Starting at the West wall along the length of the North wall at the base of window elevation and up the columns cracking is visible in the mortar joint to the East wall. At the North East corner cracking is also visible from the upper corner diagonally down to the stair case. Also, on the South wall where the stage was infilled vertical cracking has occurred between the brick masonry and the cement masonry units. From below the bleachers the diagonal cracking on the

**Figure 8** Loose mortar at window 23 crack.

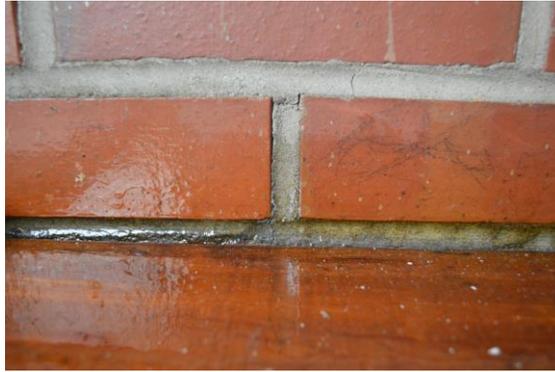
**Figure 9** West wall cracking at varnish.

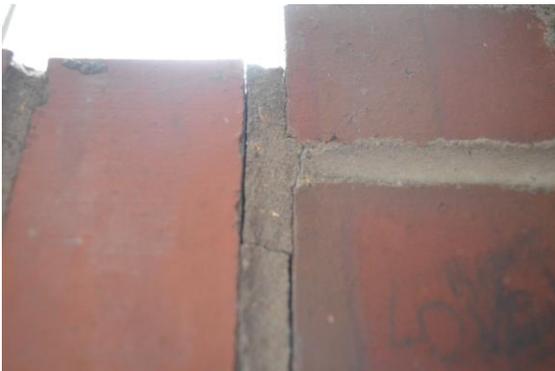
**Figure 10** Cracked mortar below window 12.

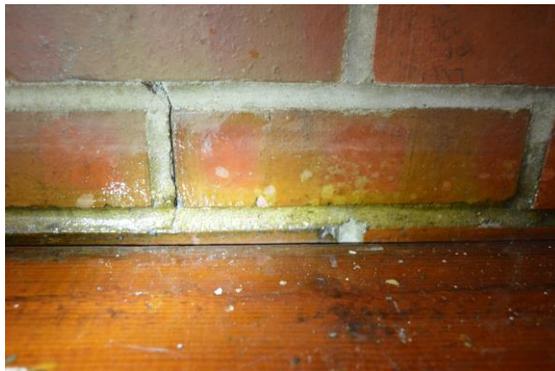
**Figure 11** Cracked varnish South below window 12.

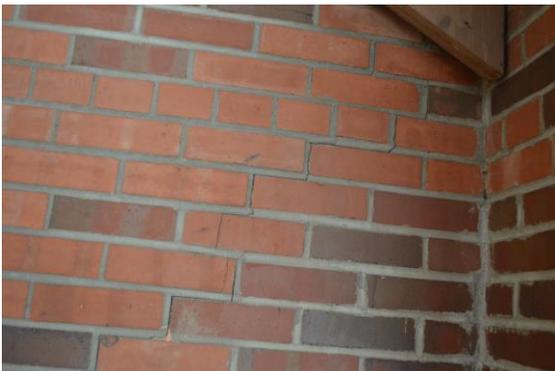
**Figure 12** Cracking at East wall South corner.

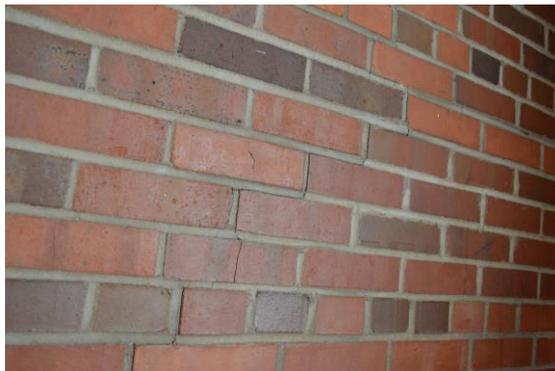
**Figure 13** Cracking at East wall South corner.

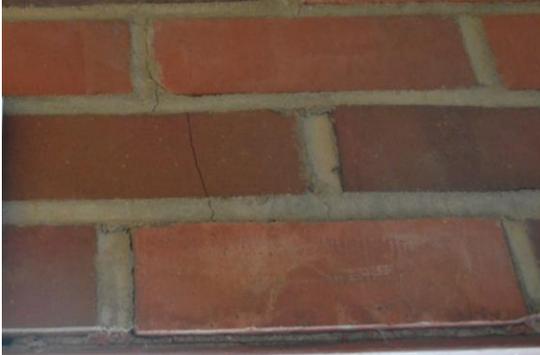
**Figure 14 Cracking above window 27.**

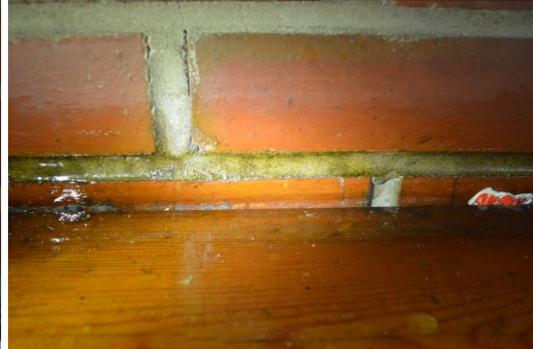
**Figure 15 Cracked varnish North West corner.**

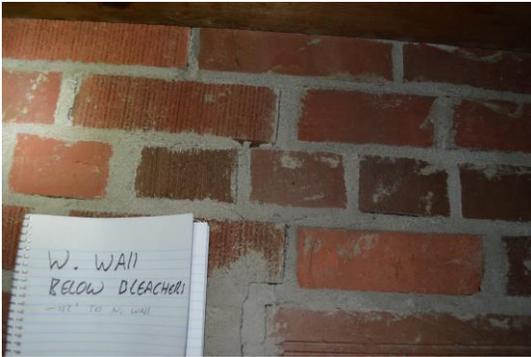
West wall in the North West corner what appears to be the crack from above travels down to where it terminates at the bond beam.

**Figure 16 West wall crack below bleachers.**

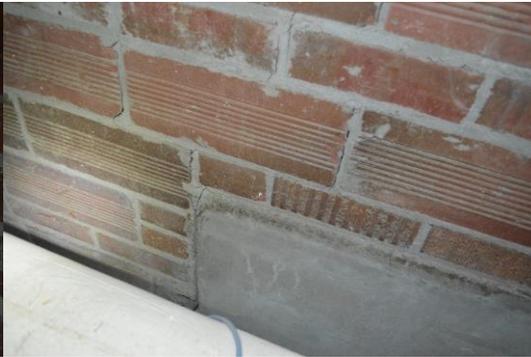
**Figure 17 Wall crack West wall at bond beam.**

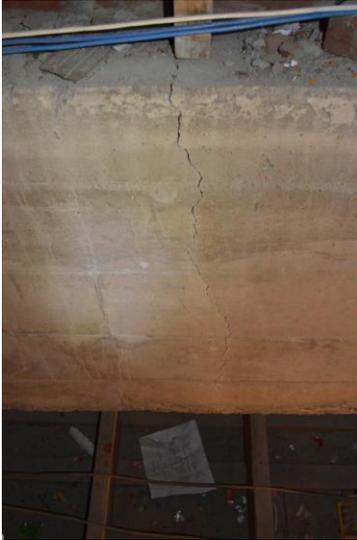
Along the bond beams at the North wall cracking was found to be typically located within the middle 1/3 of the beam span with 1 or 2 cracks per bond beam. The cracks were vertical in nature and were typically 1/8 of an inch at the top and a tight hairline at the bottom indicating that they are shrinkage based and that there may be reinforcing located at the bottom of the beams. This is supported by the finding of a void in the concrete along the bond beam between column 4 and 5 at 22-3/4" from column 5 in the upper portion of the beam. This void shows a vertical #3 shear tie and a #8 horizontal bar bent at 45° toward the bottom of the beam. At the South wall of the building the bond beams were also visible from the mechanical space below the bleachers.

**Figure 18** Typ crack in North bond beams.

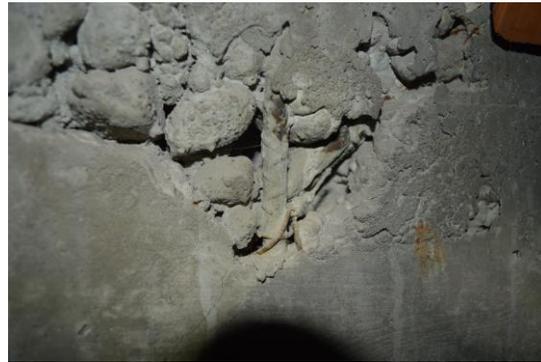
**Figure 19** Visible rebar in bond beam between 3&4

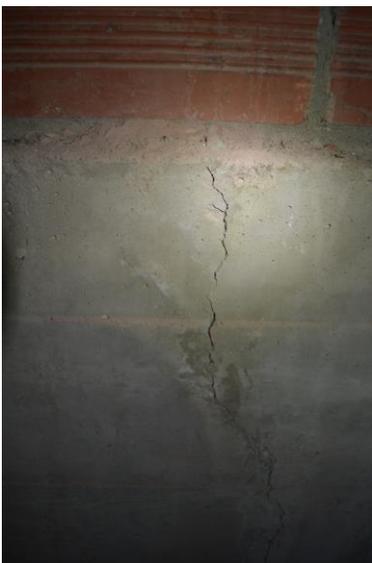
At the South wall there was an increase in cracking regularity typically finding 5 or 6 cracks per bond beam. The South bond beams had cracking that trended both vertically and diagonally some of these cracks were similar to the North bond beams being wider at the top and narrow at the bottom and some of the cracks were consistent top to bottom. The cracking found at the South wall indicates similar reinforcing to the North wall bond beams shrinkage cracks. The increase in cracking reflects the failure of the parapet on this side of the building and the forces induced on the system.

**Figure 20** Typ. vertical crack in South bond beam.

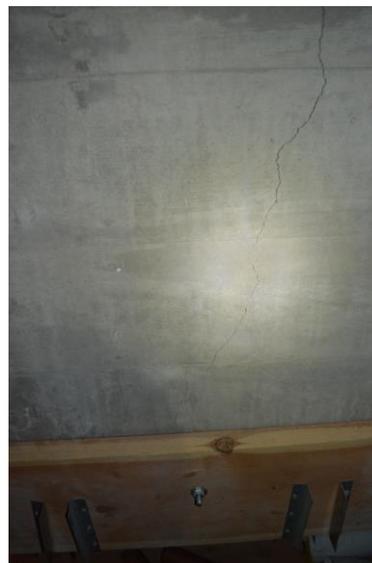
**Figure 21** Typ. diagonal crack in South Bond Beam.

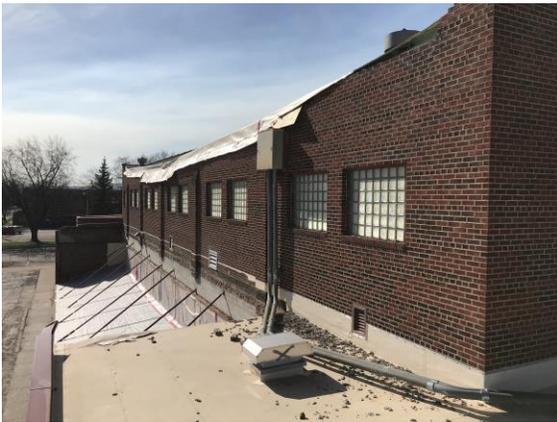
The failure at the parapet was also observed with the failure occurring where the unreinforced masonry units transitioned from a 2 wythe at the parapet to the 3 wythe of the wall. From the description given the parapets appeared to have initiated between trusses 2 and 3, the wall deflected away from the building with snow curling behind it as it slid off the roof until the wall became unstable and fell landing on the roof of the locker rooms below. It was visible where the roof membrane had torn at each of the locations where it was attached to the unreinforced brick masonry. Also found at the exterior of the building was cracking from the parapet failure around the corners of the building.

**Figure 22 Failed South wall parapet.**

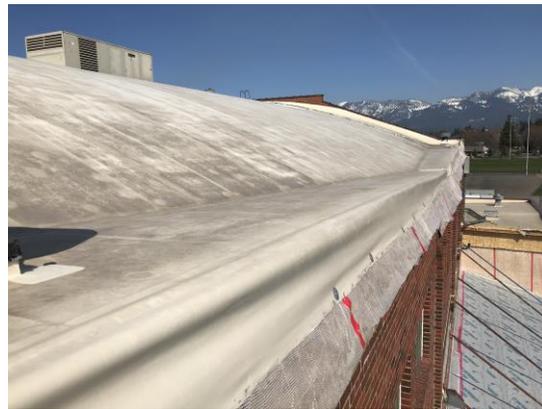
**Figure 23 Failed South wall parapet.**

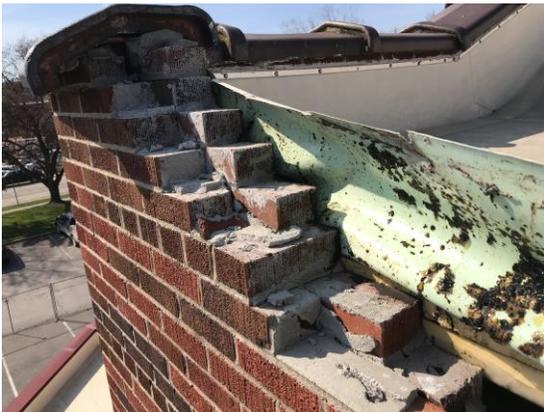
**Figure 24 Failed parapet unreinforced masonry.**

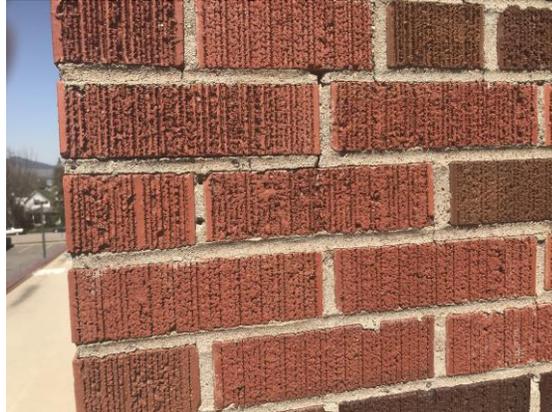
**Figure 25 South wall crack at parapet, West end.**

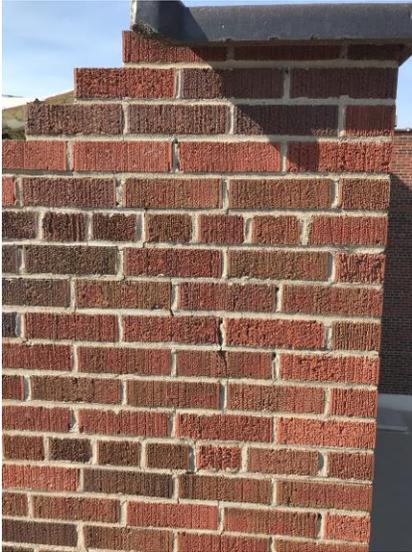
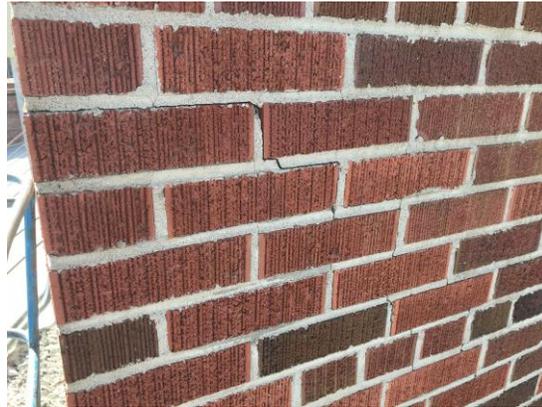
**Figure 26 South wall crack at parapet, East end. Figure 27 East wall crack at South parapet failure.**

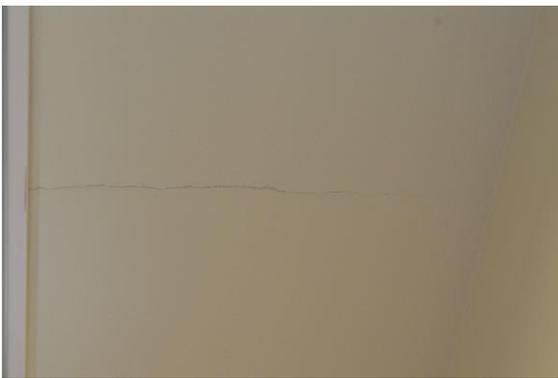
Cracking was also found in the occupiable space of the ground level. Cracking was found in the gypsum wall board seams and was located at the East, West, and South sides of the building. There was an increase in occurrence along the South hallway of the building where cracking was found at nearly all gypsum seams along the hallway ceiling and in the band room walls and ceiling all of which appeared to be new. Along with cracking at the gypsum wall seams it was described to me that one of the ceiling panels fell from the ceiling of the band room and that one of the light fixtures in the South end of the foyer had fallen from its bracketing shortly after the parapet failure. The fallen panel was visibly broken and moved to a wall while the light fixture still was hanging from the ceiling. At the East wing of the building cracking was found in the library at the corners of the room and in the upper portion of the interior wall and appeared to be new and at gypsum wall board seams. Cracking at the West side of the building was found in the mechanical room and along the hallway and above the doorways all of which appear to be new and at gypsum wall board seams.

**Figure 28 Typ. cracking in South hallway.**

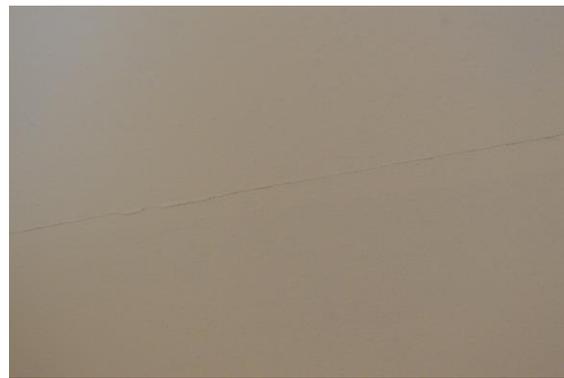
**Figure 29 Typ. cracking in South hallway.**

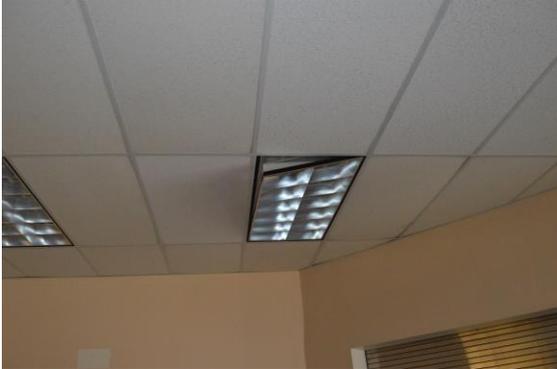
**Figure 30** Falling light fixture in S.W. lobby.

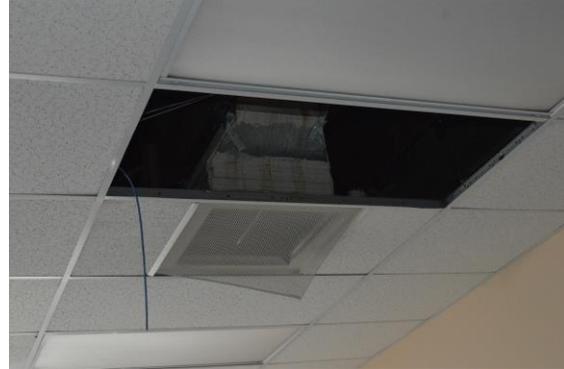
**Figure 31** Missing ceiling tile in band room.

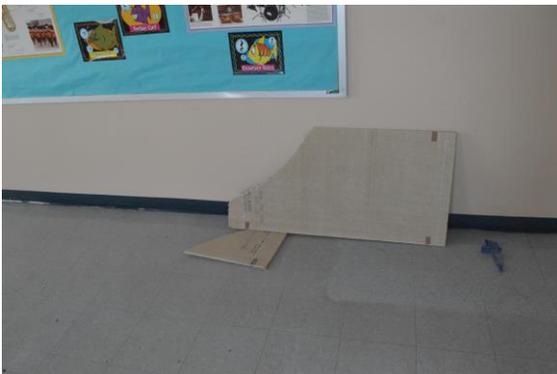
**Figure 32** Broken ceiling tile in band room.

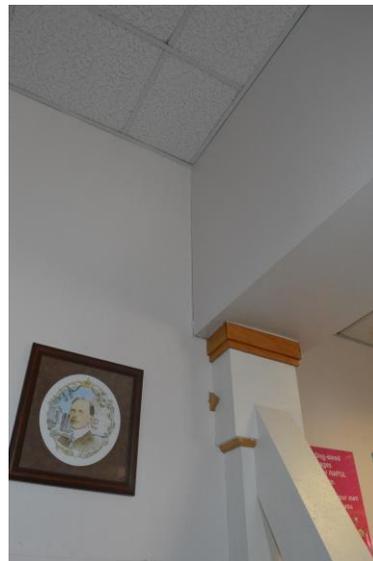
**Figure 33** Cracking in Library at ceiling.

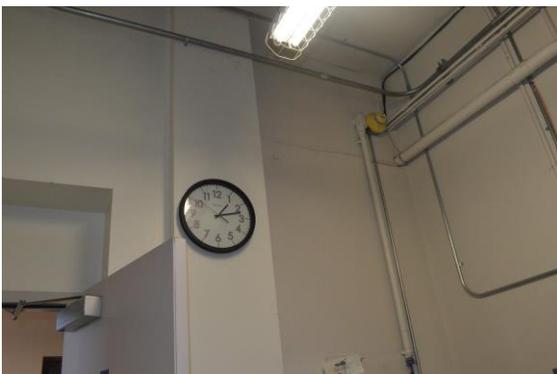
**Figure 34** Crack in West mechanical room.

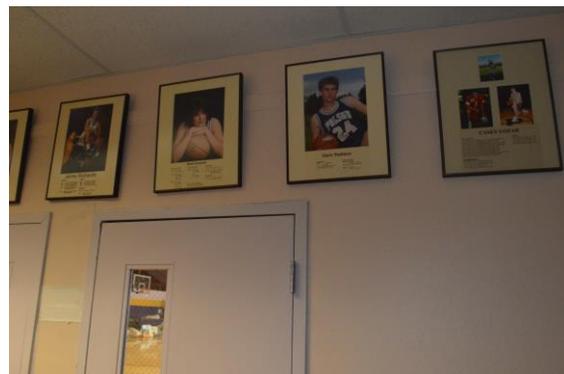
**Figure 35** Crack above doors in West hallway.

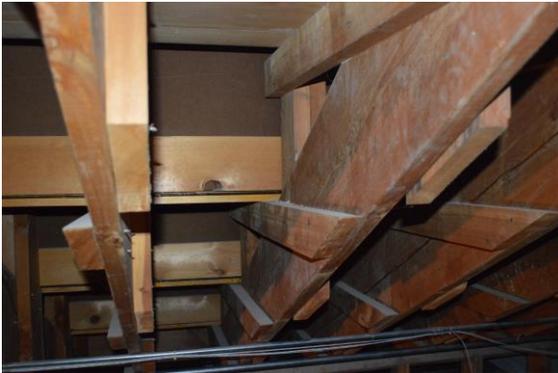
**Figure 36 Typ. bleacher framing.**

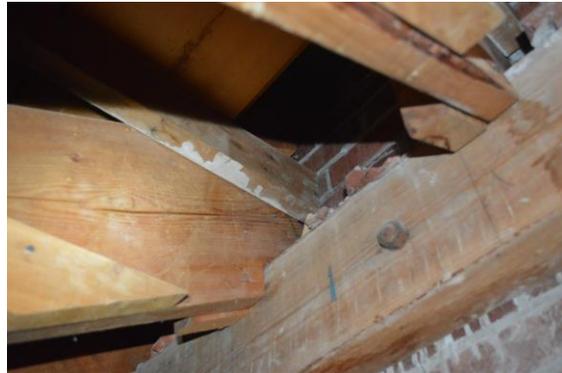
**Figure 37 Typ. bleacher bearing at wall.**

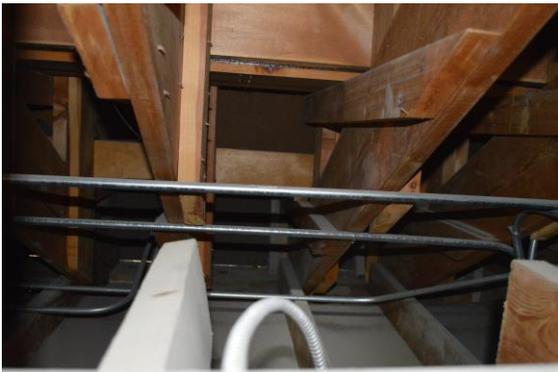
**Figure 38 North bleacher bearing at wall.**

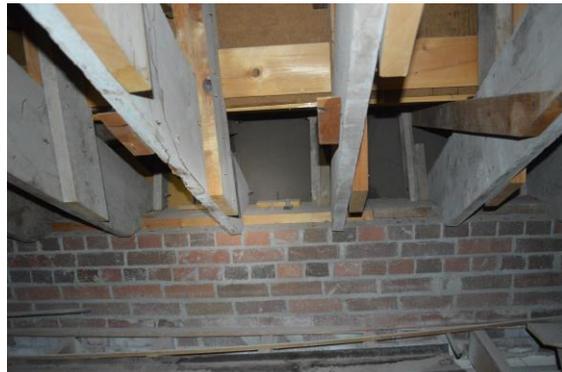
**Figure 39 West bleacher bearing at brick wall.**

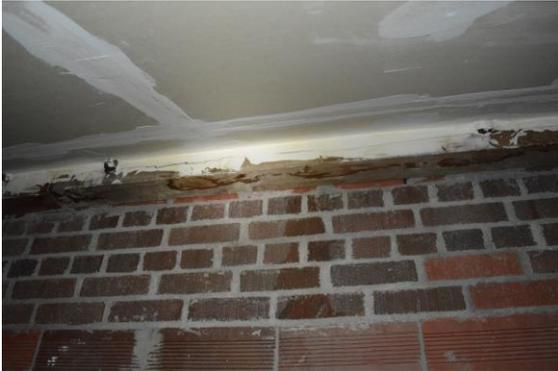
Under the South bleachers was found that the gypsum sheathing tape seam joining the gypsum wall board installed to the underside of the bleachers framing to the rim board at the wall had separated. This separation occurred most heavily between columns 2 and 3. It is visible where the tape seam has separated and there was loose gypsum flaking found below the separation indicating it happened recently.

**Figure 40 Separated gyp. tape at S. wall col. 2-3**

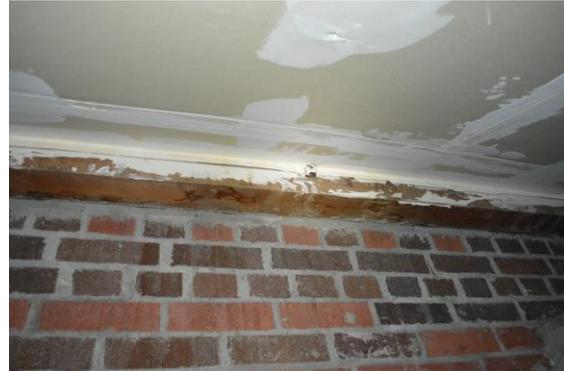
**Figure 41 Separated gyp. tape at S. wall col. 2-3**

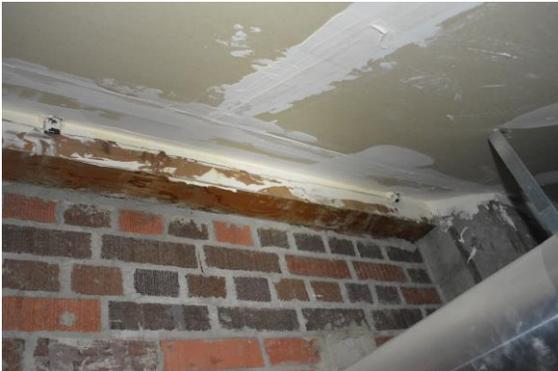
**Figure 42 Separated gyp. tape at S. wall col. 2-3**

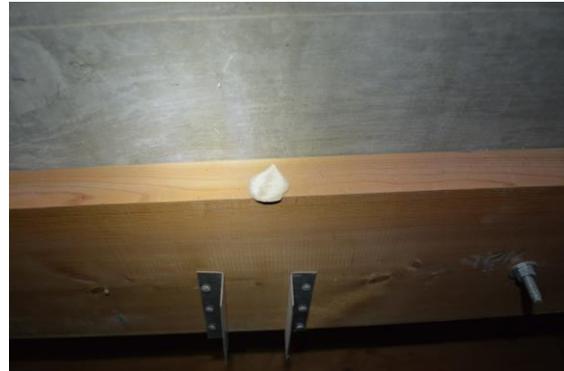
**Figure 43 Loose gyp. mud found below ledger.**

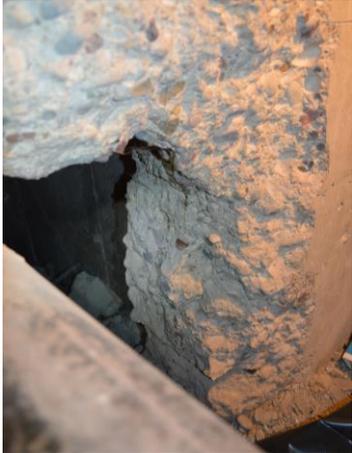
**Figure 44 North foundation wall reinforcing.**

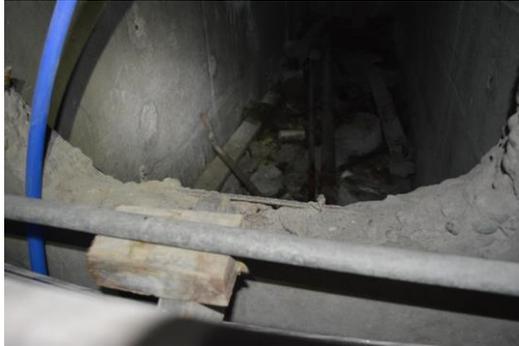
**Figure 45 South foundation wall reinforcing.**

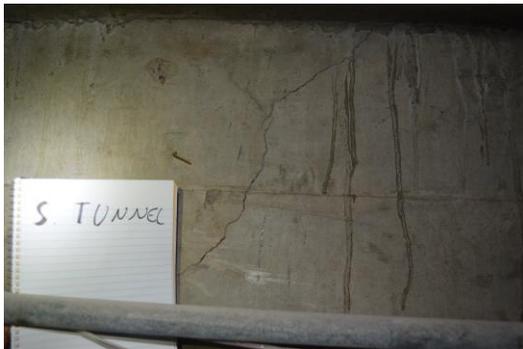
Within the chase it was found that the North foundation walls had only occasional hairline cracking. At the South side of the building the foundation walls had more cracking, hairline and wider cracks were found along the foundation wall.

**Figure 46 Cracking in South foundation wall.**

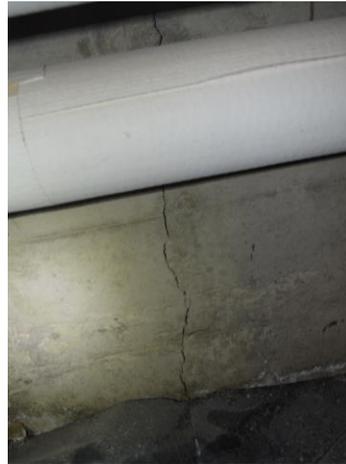
**Figure 47 Cracking in South foundation wall.**

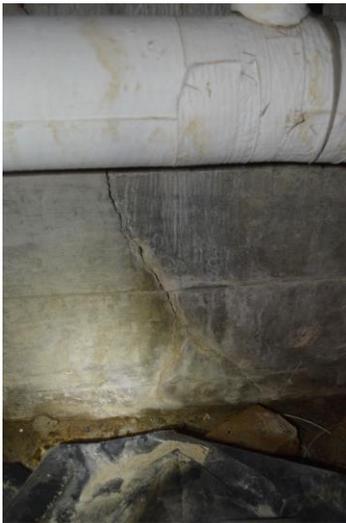
**Figure 48 Cracking in South foundation wall.**

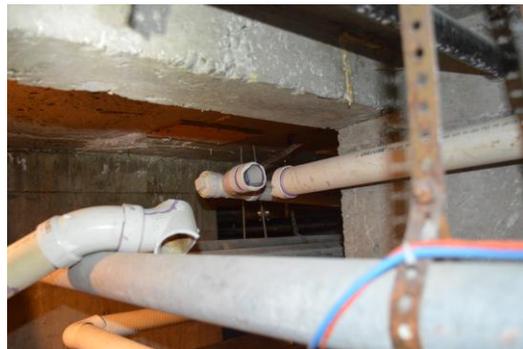
**Figure 49 Broken pipes below locker rooms.**

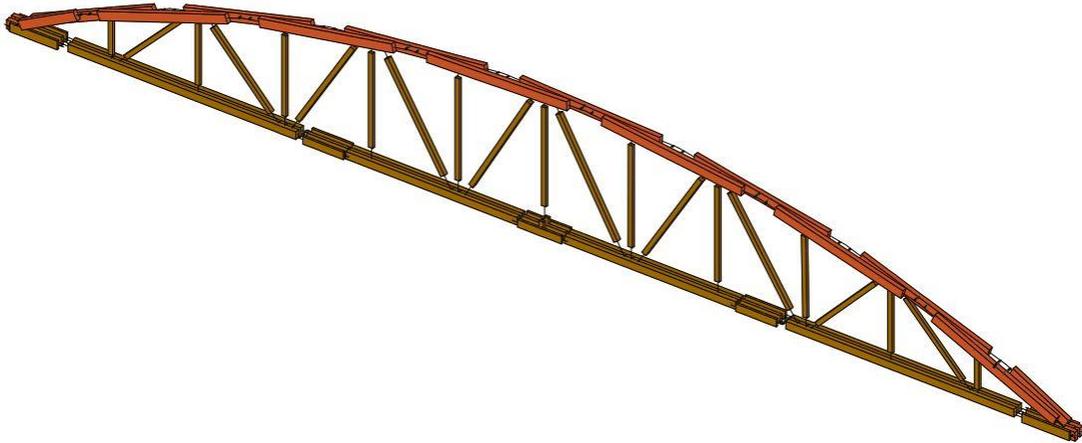
The truss model various loading results make apparent that the truss can support the design loads from the initial design before the building was constructed. When the snow loads are adjusted to the current load requirements and the additional loads from the mechanical piping and duct work are added the truss bottom chord members become stressed to 99% of their ultimate capacity. Next the load from the falling parapet was added to the top chord of the truss these members become stressed to 102% of the members ultimate capacity. This increase causes the truss members to exceed their ultimate design capacity set by the ASCE 41-17 and may have created internal lateen damages that are not readily visible. The possible lateen damages within the truss members or at connections may have left the truss members in a state of reduced performance that will limit the trusses ability to resist the design loads and reduce the truss members ultimate capacity by an unknown amount. It is our opinion that the trusses will need to be further examined to determine if there are any retrofit/repaired measures that can be implemented to ensure the trusses will meet the loads and standards set by the current code.

**Figure 50 Bowstring truss model isometric view.**
